# Failure Analysis & Prevention

Fundamental Sources of Failure: Deficient material & selection poor assembly

DHEERENDRA KUMAR DWIVEDI

Fundamental Sources of Failure: Poor service condition and maintenance

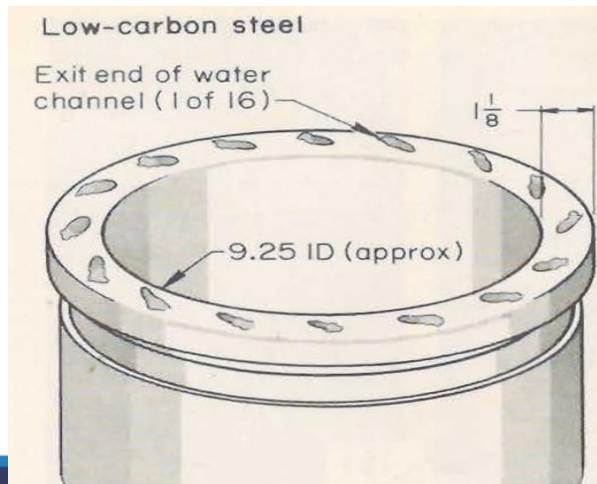
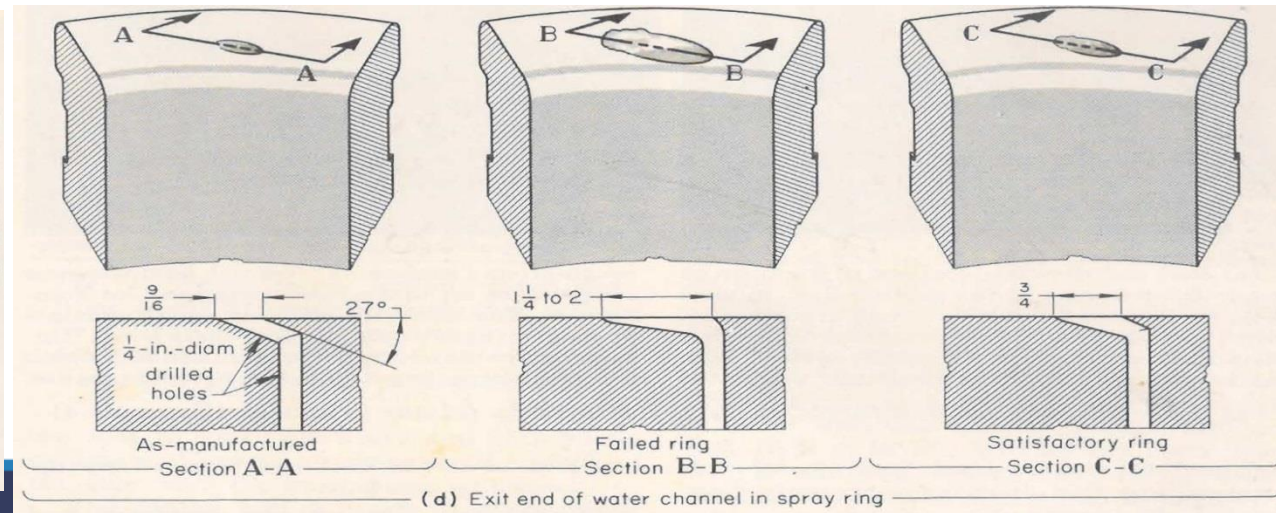
Failure of carbon steel of spray ring

Failed pre-maturely within 4-5 months as compared other doing well for last 4 years.

Failure judged from drop in curing temperature (177-182 degree C) being done through hot water sprays at 193 degree C

- Examination: pits with irregular shaped opening of spray nozzle without corrosion
- Chemical analysis: 0.11 C lower as compared to satisfactory performing ring 0.2C while same other residual elements
- Metallography: satisfactory ring: fine pearlite ferrite with stringer of pearlite and hardness HRB 55 while failed one had coarse ferrite and pearlite with hardness of HRB 40

- **Conclusions:**
  - Failure of desired curing temperature was due to enlargement of opening of spray ring which in turn increased agitation, reduced velocity that led to lower heat transfer
  - Erosion caused pitting due to cavitation
  - Low carbon, low hardness and coarse grain size reduced erosion resistance
- **Corrective action**
  - Replace the steel with proper composition with sub-critical annealing so that final grain size not more than ASTM 7 and min. HRB 55.
  - Thereafter, no further failure of spray rings was observed.

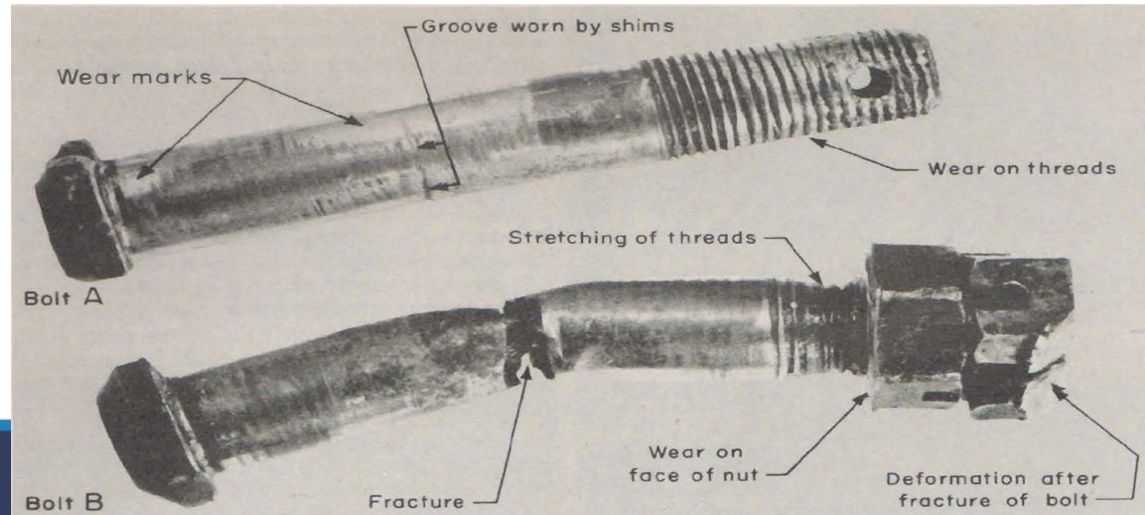
- **Case:** A 4 cylinder engine broke down with fracture of piston, end of connecting rod.
- **Disassembly and examination:** occurred due to failure of two connecting rod bolts used for joining of piston with connecting rod.
- One bolt had no nut showed wear marks

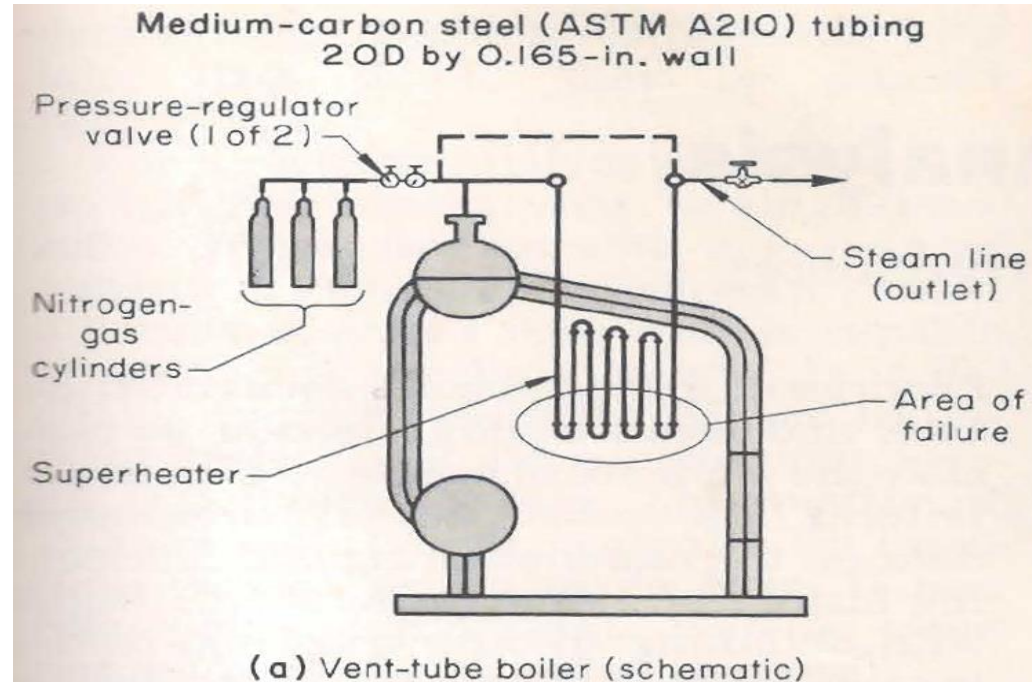
- During hydrostatic testing of 15 year old of boiler showed leakage in super-heater tubes at  $400^{\circ}\text{C}$  and 700 psi.
- Tubes of 50 mm size and 4.12 mm thickness had been in service for nine year at 650 psi at  $400^{\circ}\text{C}$

- **Visual:** black adherent magnetic scale with localised presence of powdery, loose, none-magnetic black scale showed pits on removal
- **Analysis of deposit:** XRD showed  $\text{Fe}_3\text{O}_4$  (black iron oxides),  $\text{Fe}_2\text{O}_3$  (red dust),  $\text{FeO}$  without chlorides
- **Metallography:** Normal medium carbo steel structure, no segregation and heterogeneity

- Absence of chloride showed no HCL effect used for cleaning of tubes
- $\text{Fe}_3\text{O}_4$  formation suggest presence of little oxygen for pitting
- $\text{Fe}_2\text{O}_3$  from loose, powdery none-magnetic brown deposit suggests pitting caused by presence of excess oxygen. Observed in normal moist corrosion.
- History revealed that during shot down of 15 days annual overhaul for requisite repairs.
- Oxygen rich condensate caused pitting in low points of bend regions during overhaul; period.

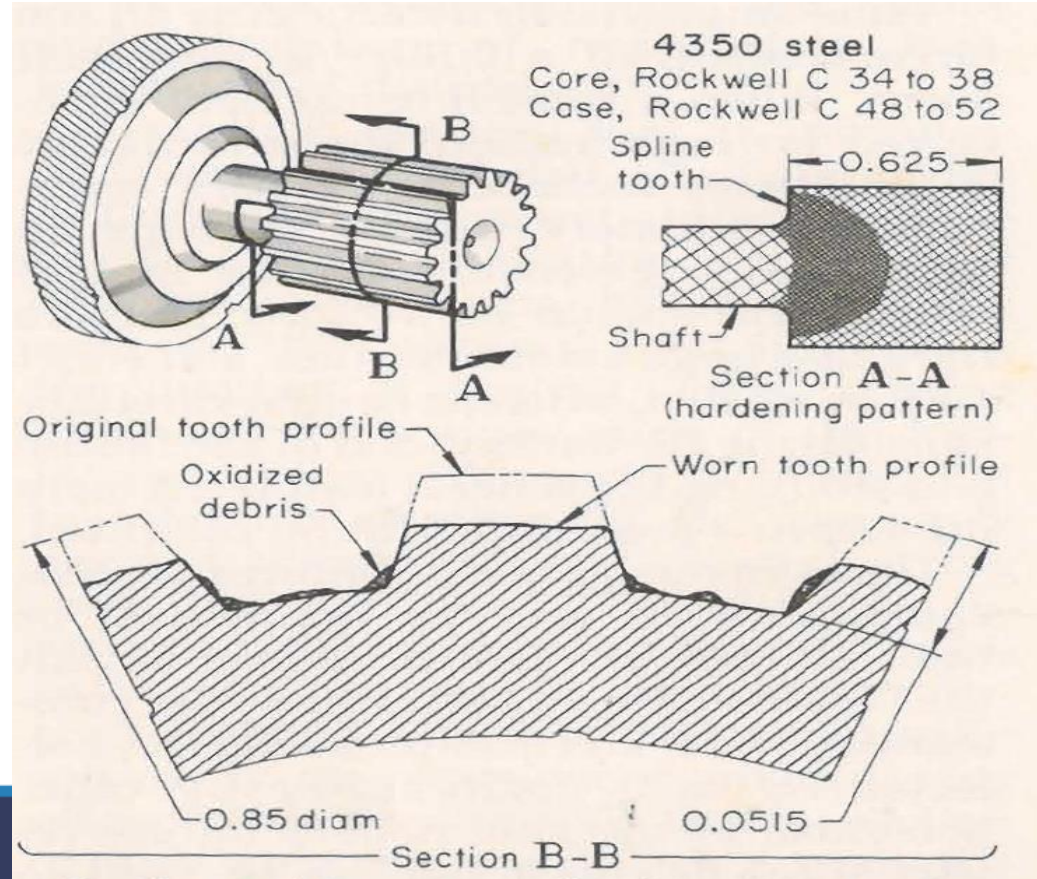
# Splined end of 4350 steel drive shaft

- Failed after 700-900 hrs
- Shaft of 4350 hardness HRC 34-38
- Case hardened to HRC 48-52 min depth 780 micron
- Counter surface C58-62 with MoS<sub>2</sub> coating

- Oxidized debris at the root area
- No residual lubricant on splined shaft
- MPT showed no surface defects
- Chemistry and metallography as expected
- Conclusion:
  - failed due to excessive wear due to breaking down of lubricating film

**Recommendation: lubrication after each 300 hrs and hardness increased from 48-53 to 58-63 RC**
