# Failure Analysis & Prevention

## Fundamental Sources of Failure: Deficient Design

DHEERENDRA KUMAR DWIVEDI  
MECHANICAL & INDUSTRIAL ENGINEERING DEPARTMENT

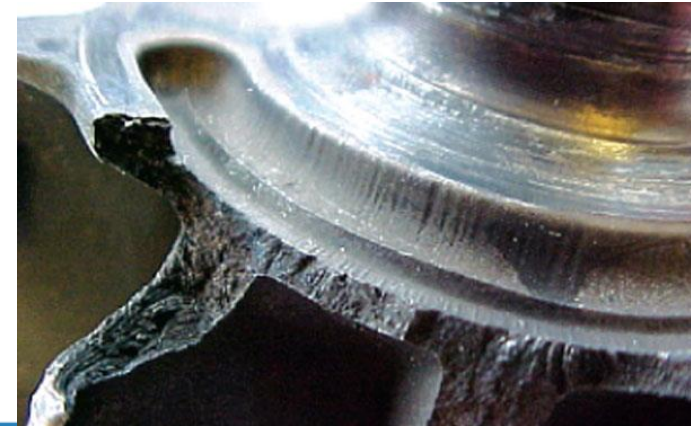
Abrupt change  
Stress "flow lines" crowd  
High stress concentration

Smoothen change  
"Flow lines" less crowded  
Lower stress concentration

- Stress concentration factor ( $K_t$ ), is a dimensionless factor
- $K_t$  is used to quantify how concentrated the stress is in a material & defined as the ratio of the highest stress in the element to the reference stress.
- Reference stress is the total stress within an element under the same loading conditions without the stress concentrators.
- Meanings, material is free from holes, cuts, shoulders or narrow passes under given load condition.

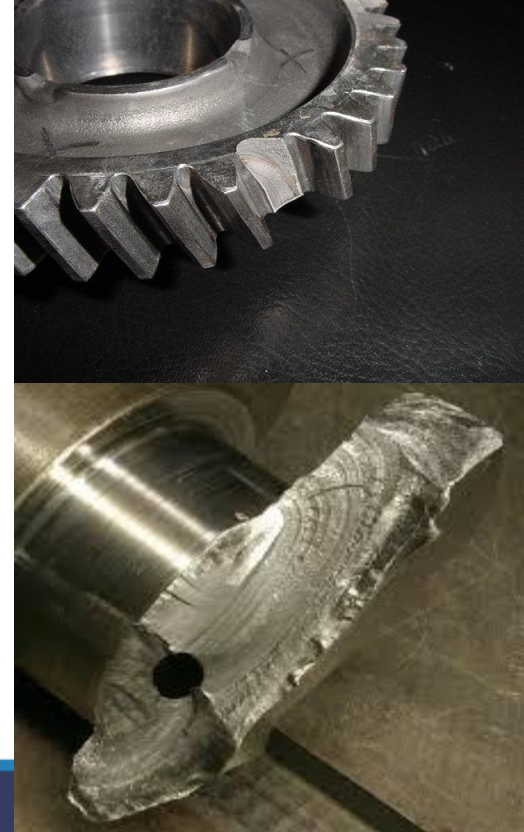
# Factors affecting SC

- Function of the geometry or shape of the part, but not its size / material
- Type of loading (axial, bending or torsional)
- Geometry of stress raiser (fillet radius, notch, hole)
- Typically assumes a linear elastic, homogeneous, isotropic material

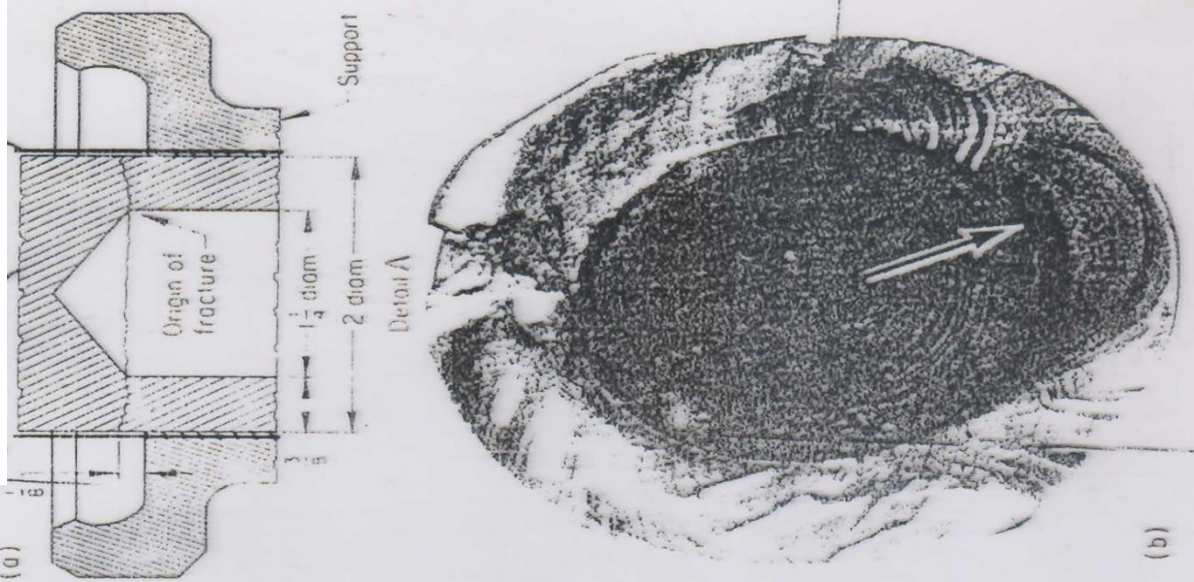
fracture extended radially from the bottom of drilled weight reducing hole to periphery of spindle. No service damage or materials defect that could be related to failure (A)

- Appearance of fracture surface is typical fatigue fracture, with cyclic one way bending , low to moderate overload, high stress concentration
- Location and orientation clamshell marks suggest fracture origin at periphery of weight reducing hole (arrow)
- Entire bottom surface of hole shows deep scored drilling tool marks

- Conformance to specification:
  - **chemical analysis** confirmed AISI 4340.
  - **NDT** did not revealed any internal dis-continuity
  - **Hardness** was in range of 38-40 RC
  - **Microstructure**: Normal tempered martensite as expected without any decarburization, inclusion and other abnormalities
- Conclusion:
  - Fracture by fatigue due to presence of circumferential notch at highly stressed area.
  - Notch presence was estimated to equivalent to 40% reduction in strength of spindle.
  - Variation in depth occurred due to missing hole depth info in drawing.
- Corrective action: Hole depth to keep it about 25 mm away from high stress area where change in cross section was taking place.
