# Failure Analysis & Prevention

## Fundamental Sources of Failure: Imperfections in Base Metal

DHEERENDRA KUMAR DWIVEDI  
MECHANICAL & INDUSTRIAL ENGINEERING DEPARTMENT

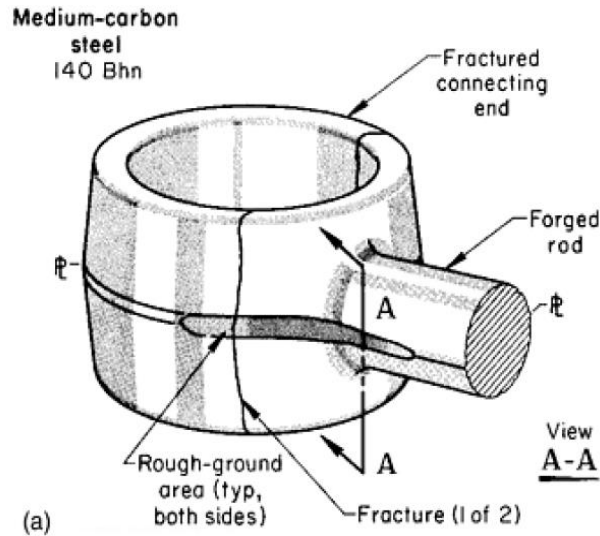
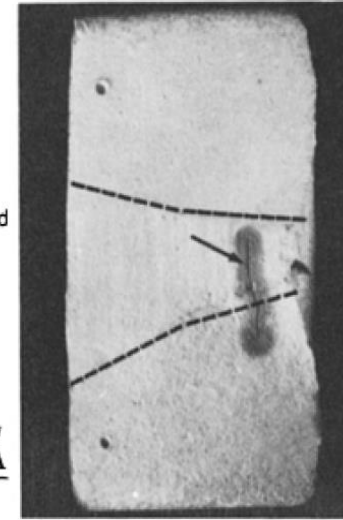
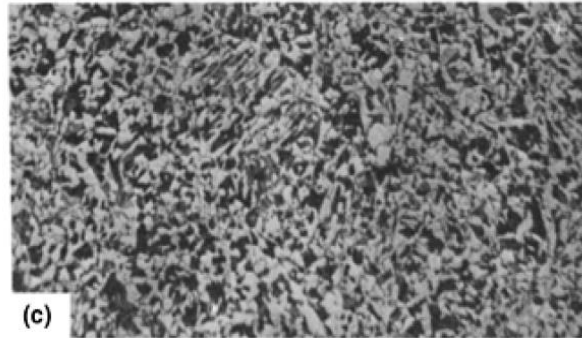
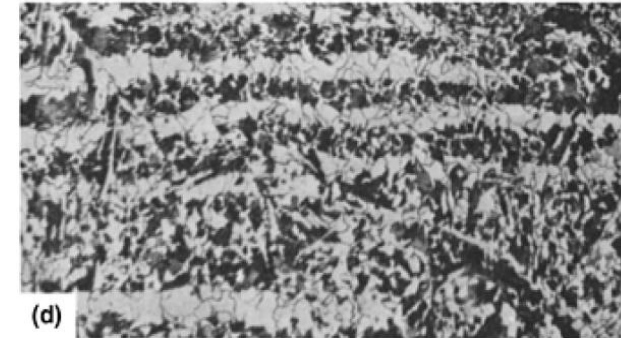
# Forging

- Fracture form transition in cross section zone
- Beach marks indicated fatigue fracture with smooth region of crack initiation
- No plastic deformation
- DPT showed fatigue cracks near fracture region with rough ground feed marks

- Medium carbon steel connecting failed
- Composition with limits
- No metallurgical imperfection
- Hardness was 140 BHN instead of 160-205 BHN
- Metallography: un-used showed homo. Pearlite with equal F/P showed proper HT
- Failed one showed banded strcture near feed marks

- Notch sensitive banded structure in high stress area
- Rough ground marks stress raiser
- Low hardness
- Recommendation: control of microstructure, hardness and finish in critical areas

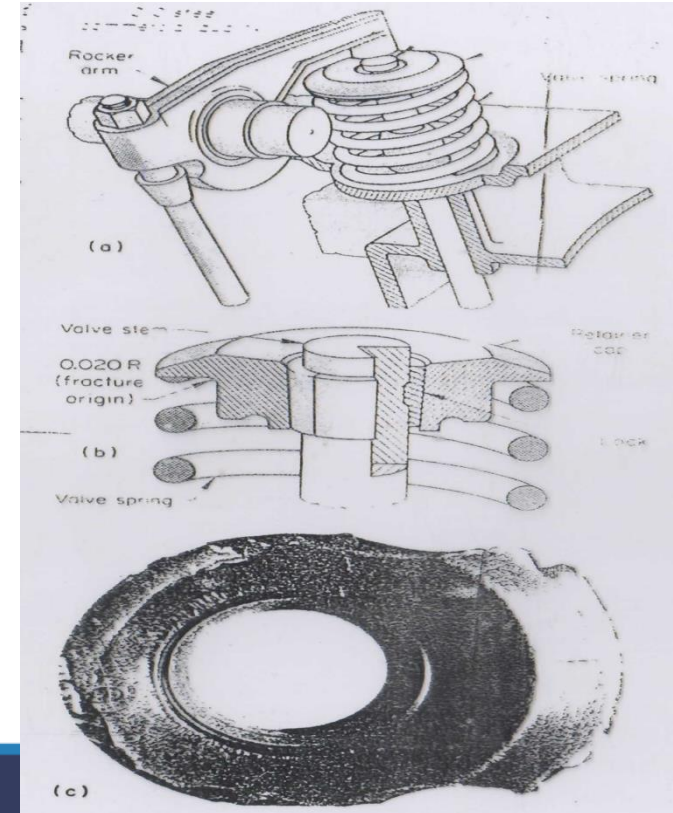
# Upgrading of a part: Premature failure of AISI 1010 steel valve spring retainer of an engine during trial

- Retainer cap failed during 8 cylinder automobile qualification run
- Cap broke off before trial run of 200 hrs at 4100 to 4600 rpm after 26 millions of cycles
- Test simulates continuous running of engine for 200 hr at 140 miles/h
- Manufacturing: made from 16 mm cold drawn 1010 steel in annealed condition
  - Forging and then trimming
  - Case hardening: carbo-nitriding for 30 min at 843 °C and oil quenching
  - Tempering at 260 °C
  - Case depth 0.025 to 0.25 mm, HRB 86 min.

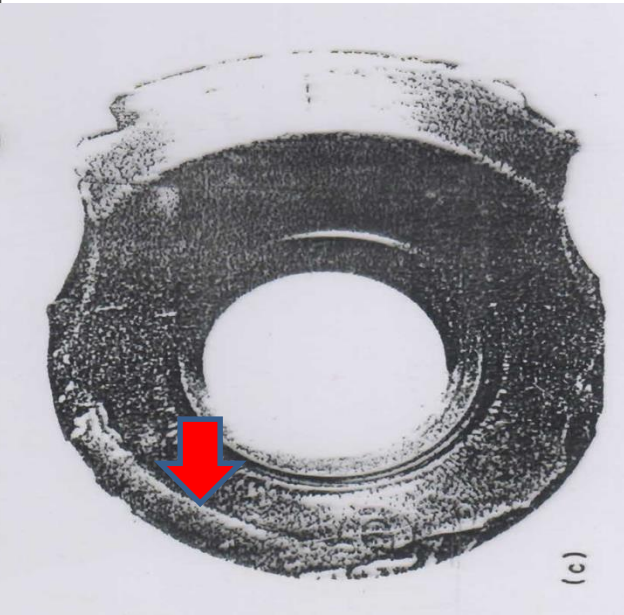
# Deficient design: upgrading

- **Macroscopy:** flange broke off from the cap periphery
- Smooth area on fracture surface is characteristics fatigue fracture with brightness (at arrow)
- Fracture initiated at outside region of the cap along the sharp fillet
- Irregular, rugged areas correspond to final fracture
- No sign of plastic deformation or shear lips
- **Metallography:.**

- Conformance to specification:
  - **chemical analysis** confirmed AISI 1010 (0.11 C, 0.48 Mn).
  - **Microscopy**: case depth 0.2 mm
  - **Hardness** was in range of 84 HRB slightly below than specified 86 units
  - **Microstructure**: Normal F & P structure as expected without any inclusion and other abnormalities
- Conclusion:
  - Fracture initiated and propagated by fatigue before final brittle fracture due to sharp fillet between pilot and flange
  - No significant material and manufacturing problems was found
- Corrective action: Design of cap fillet radius increased from 0.5 to 1.25 mm for better stress distribution. Increased fillet radius eased manufacturing also.
